Service Bulletin

Bulletin No.: 23-NA-207

Subject: Ticking, Rattle and/or Buzzing Noise Heard from inside Passenger Side

Brand:	Model:	Model Year:		VIN:		Engine:	Transmission:
		from	to	from	to		
Chevrolet	Camaro ZL1	2017	2024	—	—	6.2L (LT4)	—
	Camaro ZL1 1LE

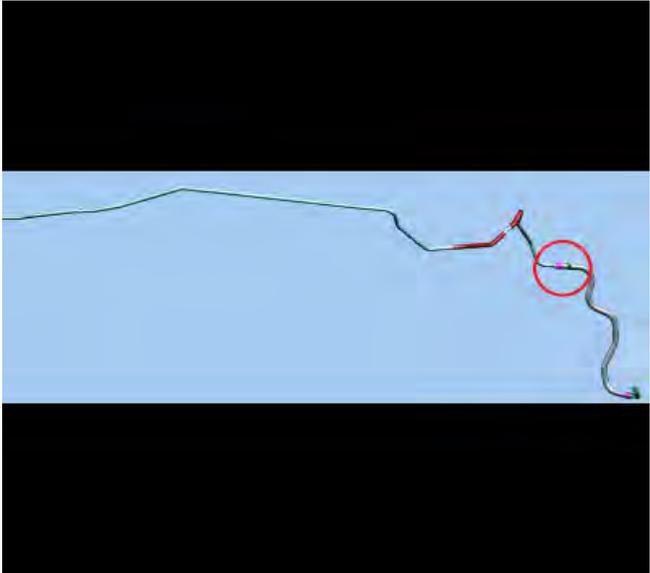
Involved Region or Country	North America, Argentina, Brazil, Bolivia, Chile, Colombia, Paraguay, Peru, Uruguay, Europe, Russia, Middle East, Israel, Palestine, China, Thailand, Other Africa
Condition	Some customers may comment on a rattle, tick or buzz noise coming from the passenger side. – The noise may be louder inside of the vehicle rather than on the outside.
Cause	<div style="text-align: right; margin-bottom: 5px;">6483330</div>

<p>This condition may be caused by the fuel feed pipe between the high-pressure fuel pump and chassis fuel line allowing high pressure pulsation back to the low side of the fuel system. – This may be due to a faulty pulse dampener internal to the part.</p>

If the pulse dampener has been validated to be the cause of the noise, replace the fuel feed pipe.

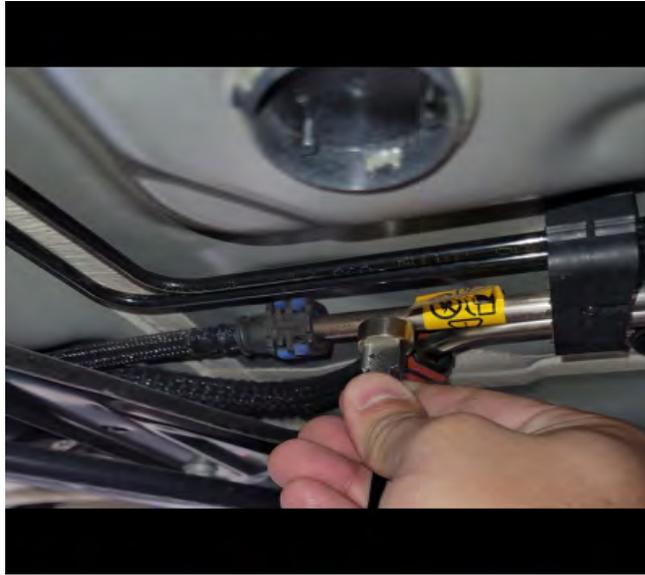
6483325

Note: There is not a good way to test this pulse dampener. Following the line underneath the vehicle, a sound check can be made in this location indicated in the graphic above, to confirm the noise is present within the fuel line.

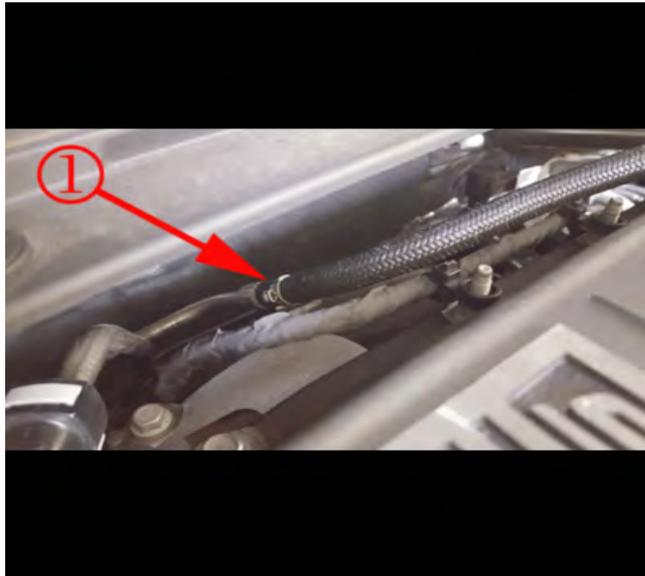
6483334

These graphic above shows the location of the chassis fuel feed pipe on the LT4 engine. This line will run along the firewall and below the vehicle. It will have a jumper line with quick disconnects at both ends. One end will connect to the chassis line and the other to the high-pressure pump feed line.

Refer to *Fuel Feed Pipe Replacement* in SI.
