Potential Issue

A sudden loss of power can occur during takeoff which can lead to rough starts and/or stalling of the vehicle.

Vehicle	2017 Camaro ZL1 Coupe with a Manual Transmission
VIN	1G1FJ1R62H019XXXX
Mileage	~1,300
Modifications	None
Owner	Travis Lambert XXXXXXXXXXXX Fairmont, WV 26554 XXX-XXX-XXXX travis_lambert@hotmail.com (Please feel free to contact me with any questions.)

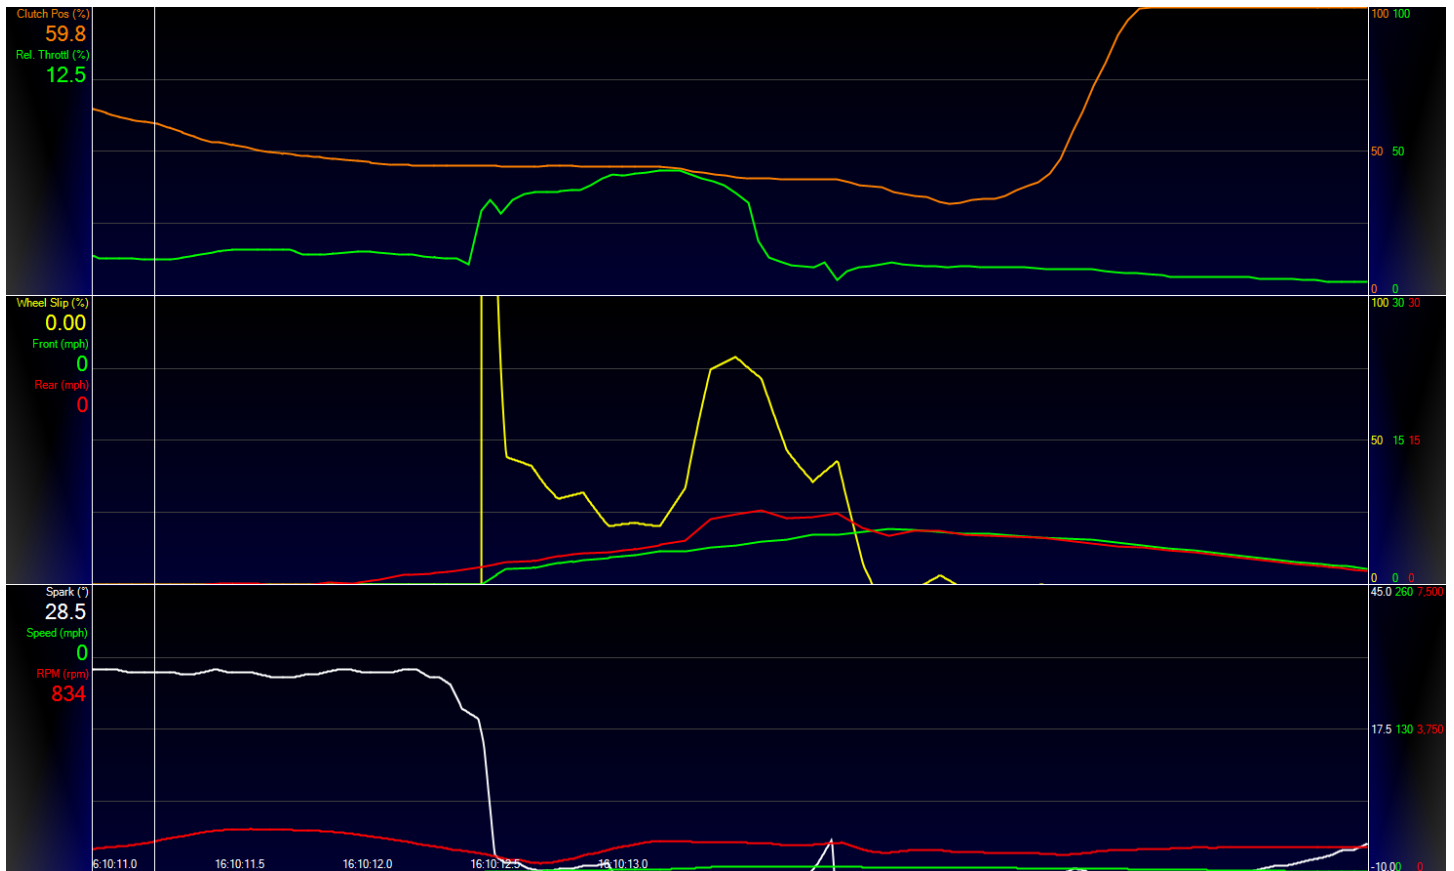
The following image is a portion of a screen capture from the VCM Scanner tool while taking off on a slight incline with a gravel surface (scale indicators are on the right side of the graph).

Pay particular attention to the initial spike in Wheel Slip% (middle graph, yellow) and how the Spark timing (lower graph, white) responds aggressively.

I certainly understand that this may be viewed as the car doing what it needs to do in order to eliminate wheel slip, but when this occurs there's less than 1.8 MPH of actual wheel slip (which is almost imperceptible on gravel). The spark timing went from about 20 degrees to -6 degrees in an instant which is jarring to the driver. Also, please keep in mind that this is simply an example meant to capture behavior similar to an event cause by error in the Wheel Slip % calculation (as opposed to actual slip).

It appears that the sudden loss of power may be due to an overly aggressive response to wheel slip at low speeds. The wheel slip may be actual slip or a spike in the calculation due to error (latency between sensor readings, slight differences in sensors, differences in tire wear, etc.).

(Also, in my opinion, it is not meaningful to display spikes in the Wheel Slip % at extremely low speeds. From the driver's perspective, the slip is negligible. I'd recommend a driven wheel speed threshold to guard against the erratic gauge behavior.)
