#17468: Service Update - Insufficient Tape/Abrasion Protection on ABS Wiring - (Apr 11, 2018)

Subject: 17468 – Insufficient Tape/Abrasion Protection on ABS Wiring

Models: 2018 Chevrolet Camaro

Reference Number: N172115540	Release Date: April 2018
Revision: 00

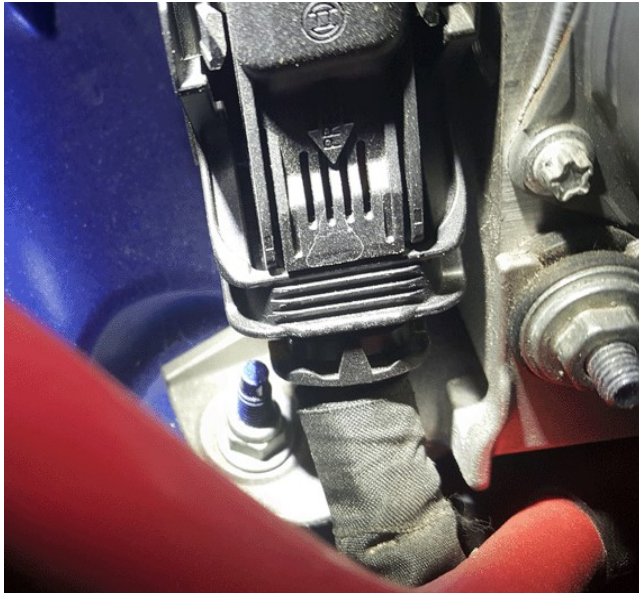
Condition	Certain 2018 model year Chevrolet Camaro vehicles may have been built with insufficient tape/abrasion protection on the Antilock Brake System (ABS) wiring near the body stud. This condition could rub through the ABS wires.
Correction	Install sleeve to wiring harness and secure with stud mounted clip.

1. Locate the wiring harness leading to the EBCM underneath the Windshield Washer Solvent Container Filler Tube.
