2020 Chevrolet Camaro V8-6.2L SC
Vehicle > Technical Service Bulletins

#13-08-116-001F: Aftermarket ALDL or DLC Interface Devices Causing Multiple Issues - (Oct 23, 2020)

Models: 2021 and Prior GM Passenger Cars and Trucks

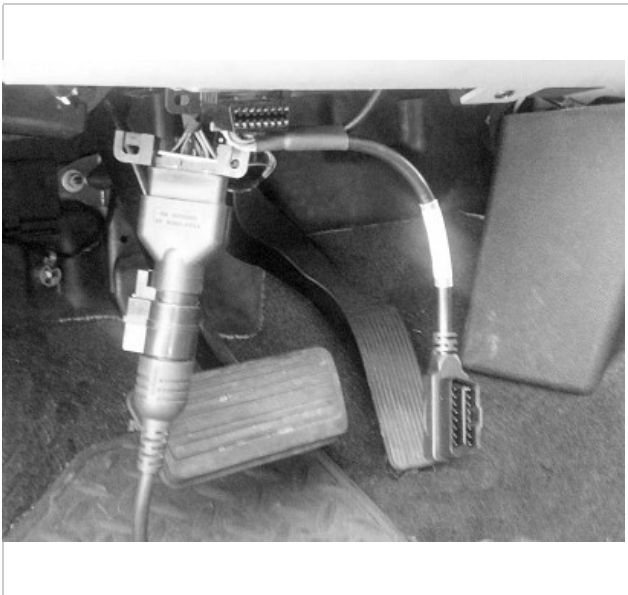
Device W/Secondary DLC Connector

This device has another DLC connector on it. The rest of the harness along with the device can be placed out of sight hidden from the technician, who may not notice the diagnostic connector is not in the factory location.
