Service Bulletin

Bulletin No.: 15-00-89-004F

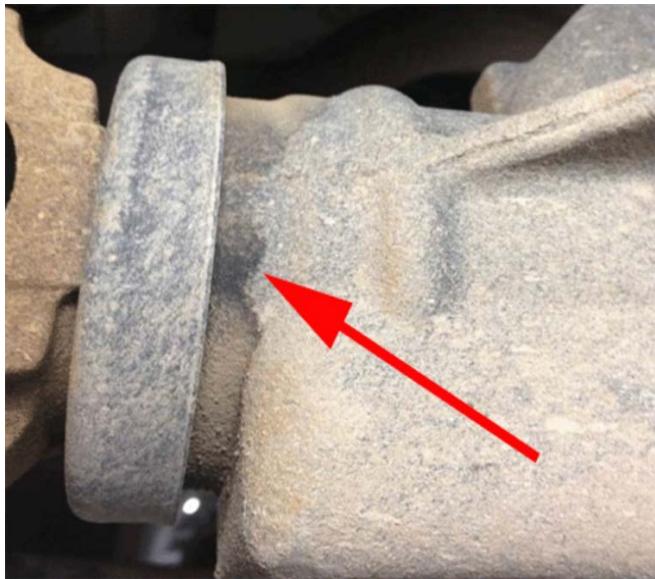
The engine illustrated above shows residual oil staining from assembly. There are no drips or leak paths present.

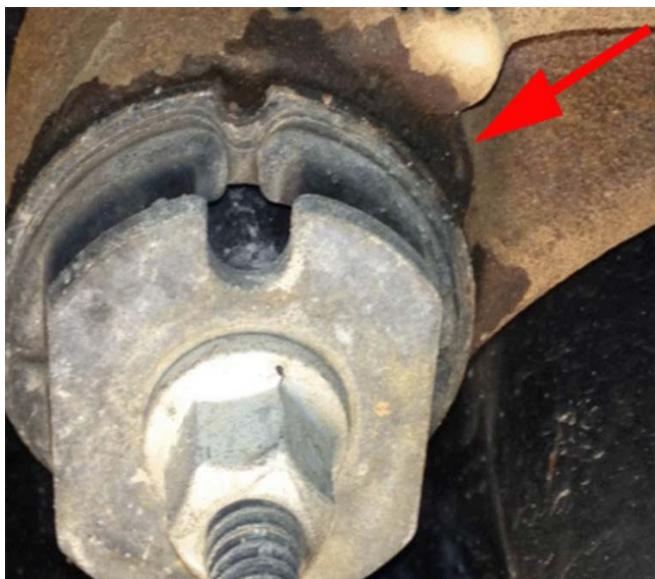
You can see the darker area where fluid has attracted dirt. There are no droplets at the bottom of the seal area.

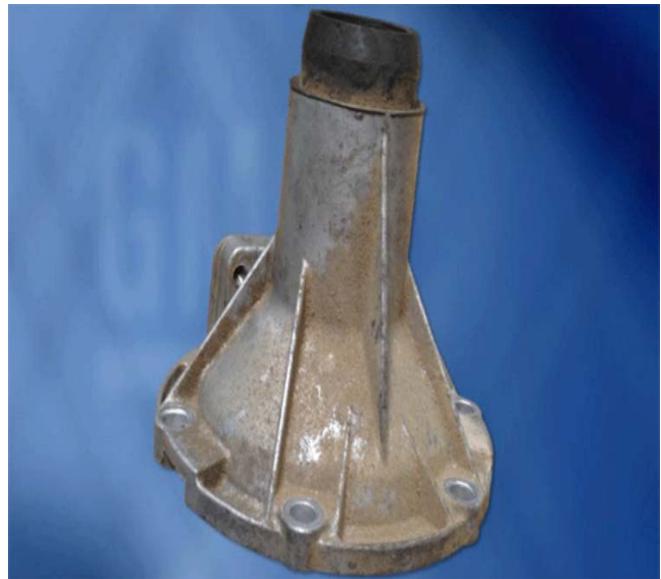
There is slight staining around the mount, but there are no droplets formed and fluid has not dripped onto other components.

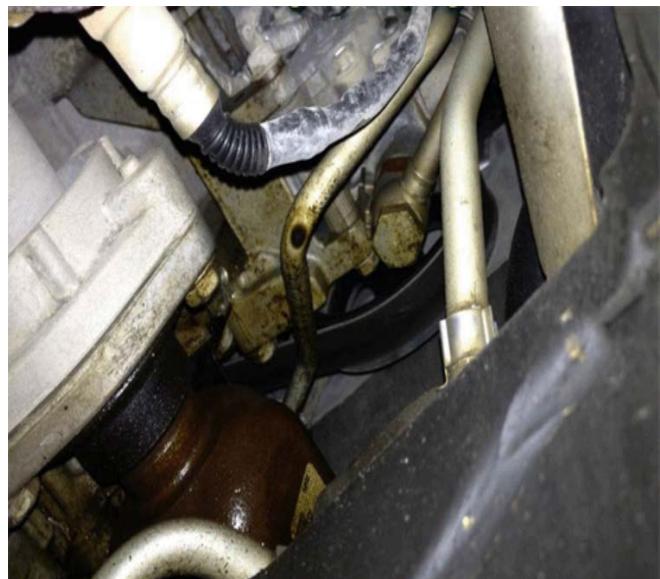
A droplet is formed on the end of the stud and the surrounding area is also covered with fluid.

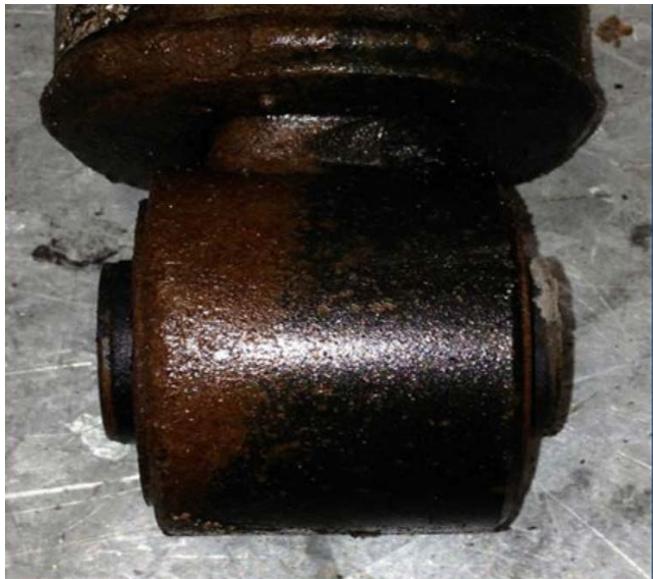
This is also a leak because there is a droplet formed on the bottom of the power steering line and fluid has dampened the drive axle.

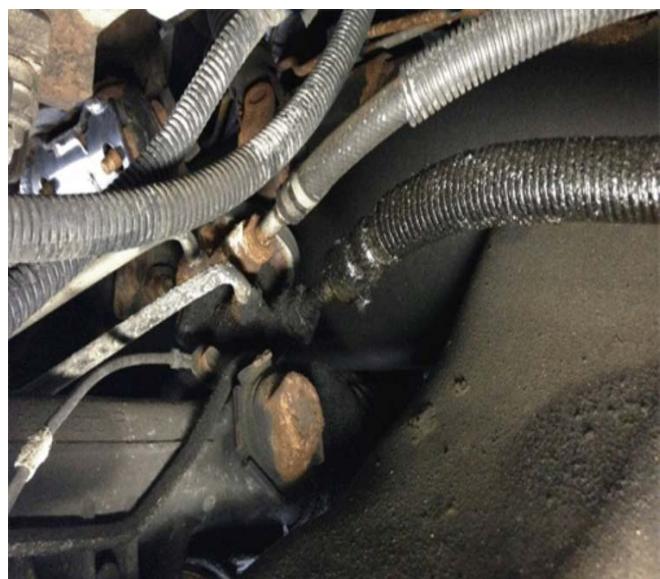
For more information on the diagnosis and replacement of shock absorbers, refer to the latest version of Service Bulletin 05-03-08-002: Information on Diagnosis and Replacement of Shock Absorber and Strut Due to Fluid Leak.
