#16-NA-042: Infotainment System Upgrade for Android Auto Feature - (Mar 2, 2016)

Subject: Infotainment System Upgrade for Android Auto Feature

What is Android Auto ?

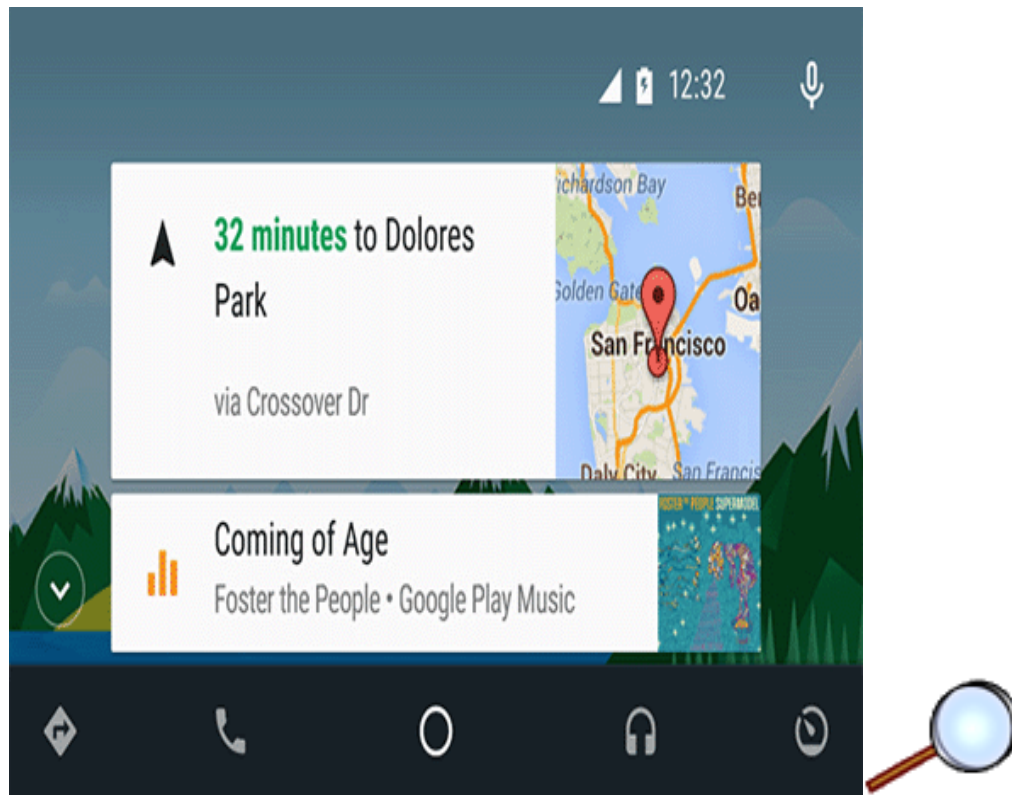
- Home Screen: Android Auto automatically brings you useful information, and organizes it into simple cards that appear just when they're needed.

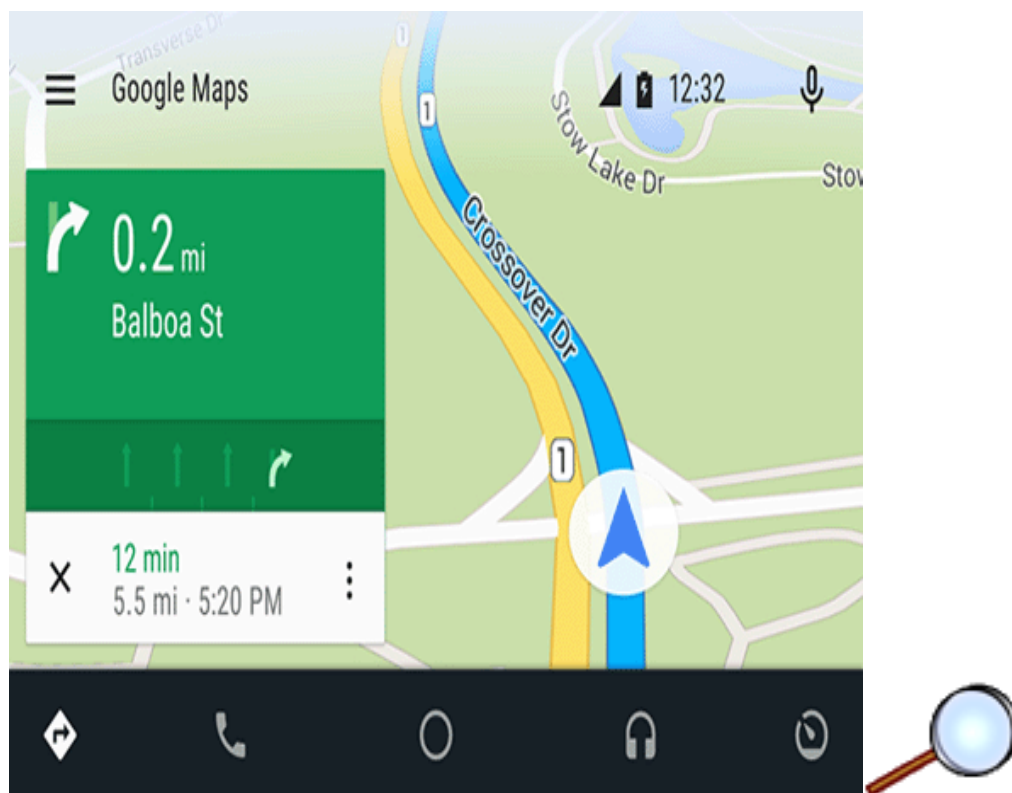
- Maps: Let Google Maps lead the way. It's easy to get where you're going with free voice-guided navigation, live traffic information, lane guidance, and more.

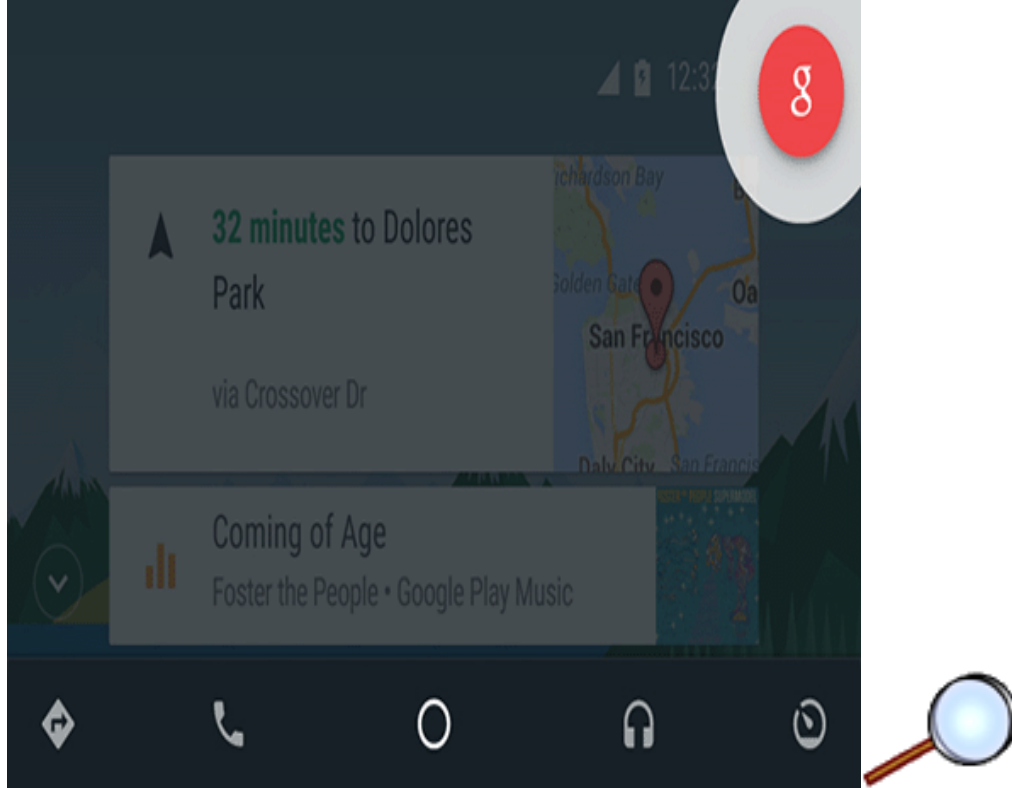
- Voice: Just say the word – Best-in-class speech technology makes controlling everything with your voice fast and easy. Send, read, and reply to your text messages; Make calls, return missed calls, and listen to voicemail – Talk to Google can help you do all these things, and more.

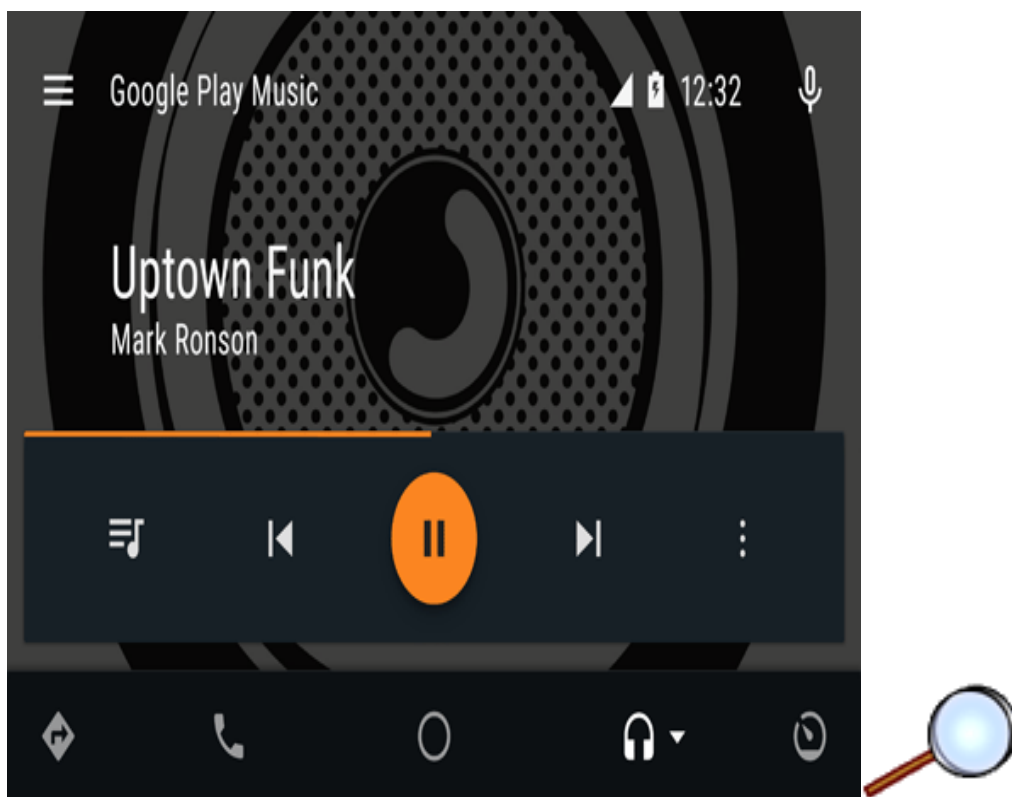
- Music: Your favorite tunes – to go! Access and stream over 30 million songs, custom playlists and more with Google Play Music.
