## Instrument Panel Upper Trim Panel Cover Replacement

### Removal Procedure

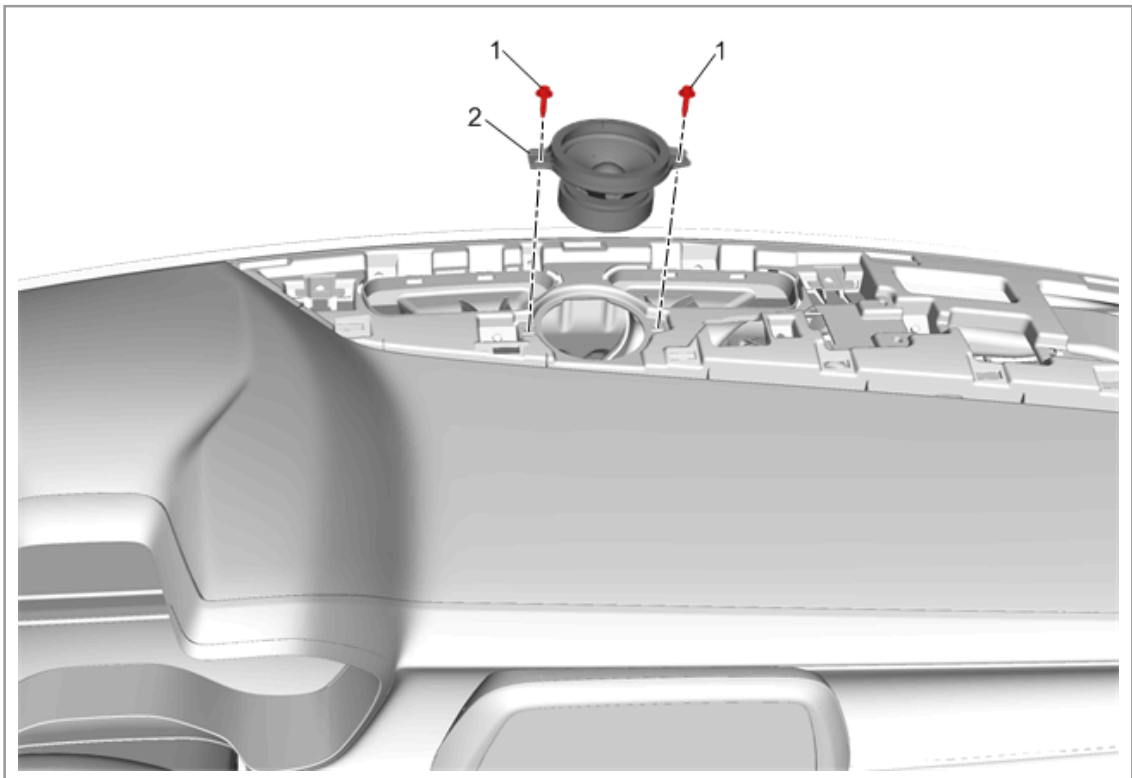
1. Radio Front Center Speaker Replacement(2) >> Remove

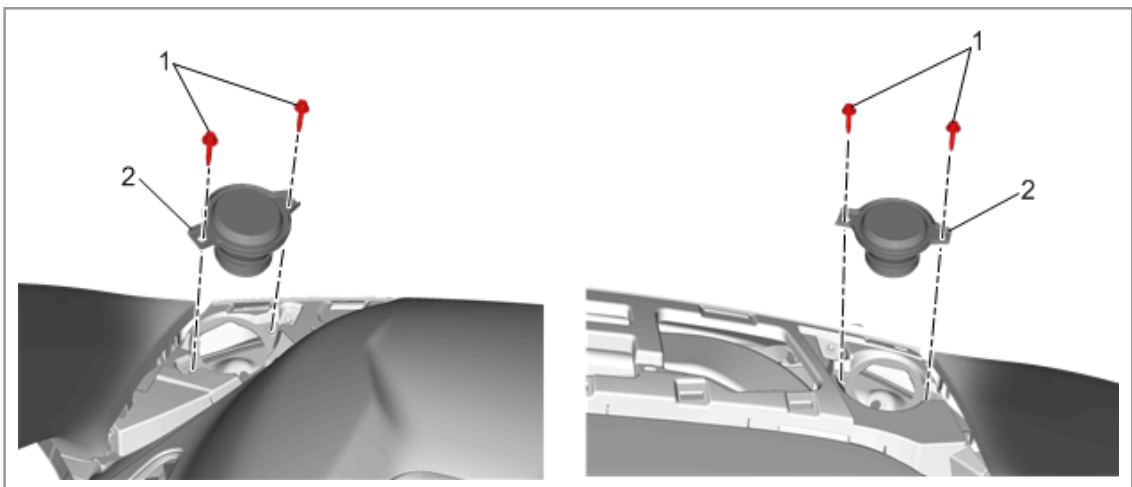
2. Radio Front Speaker Replacement(2) >> Remove

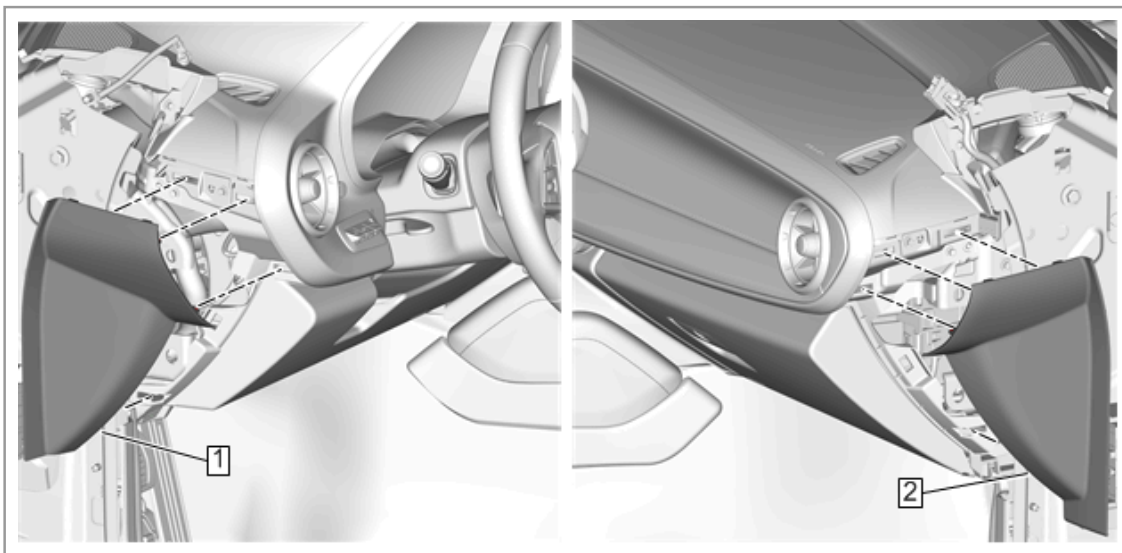
**3. Instrument Panel Outer Trim Cover Replacement(1) >> Remove**

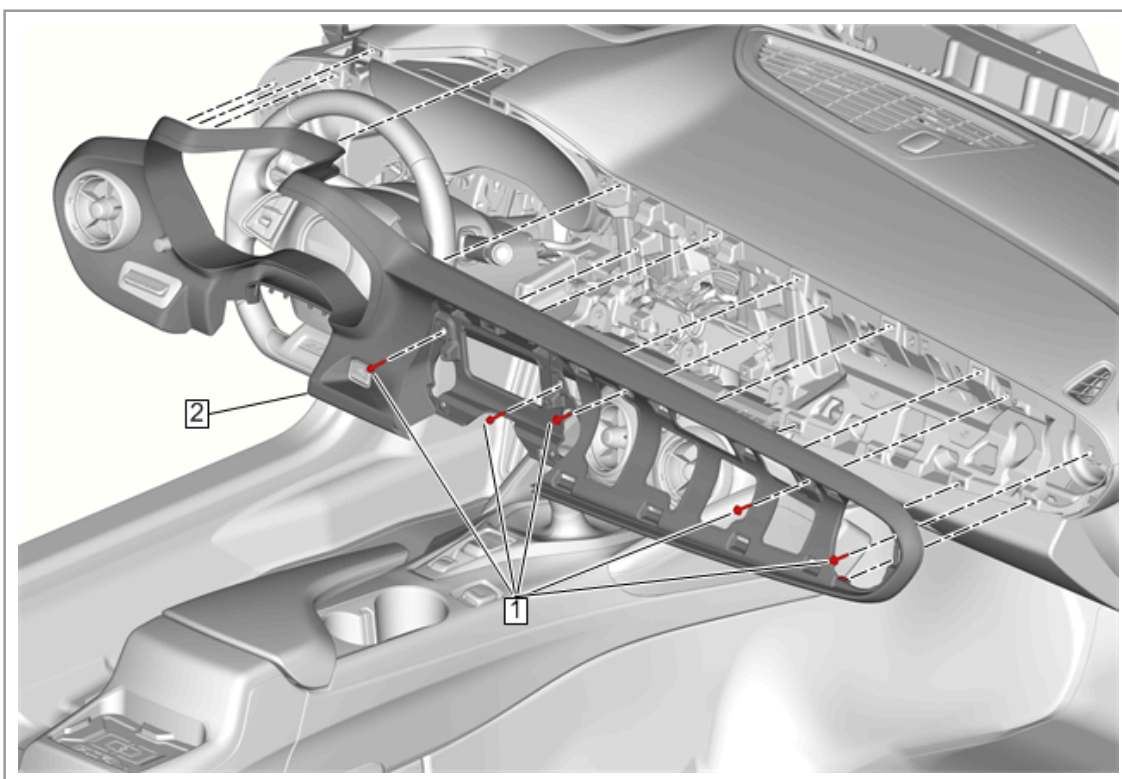
**4. Instrument Panel Cluster Trim Plate Replacement(2) >> Remove**

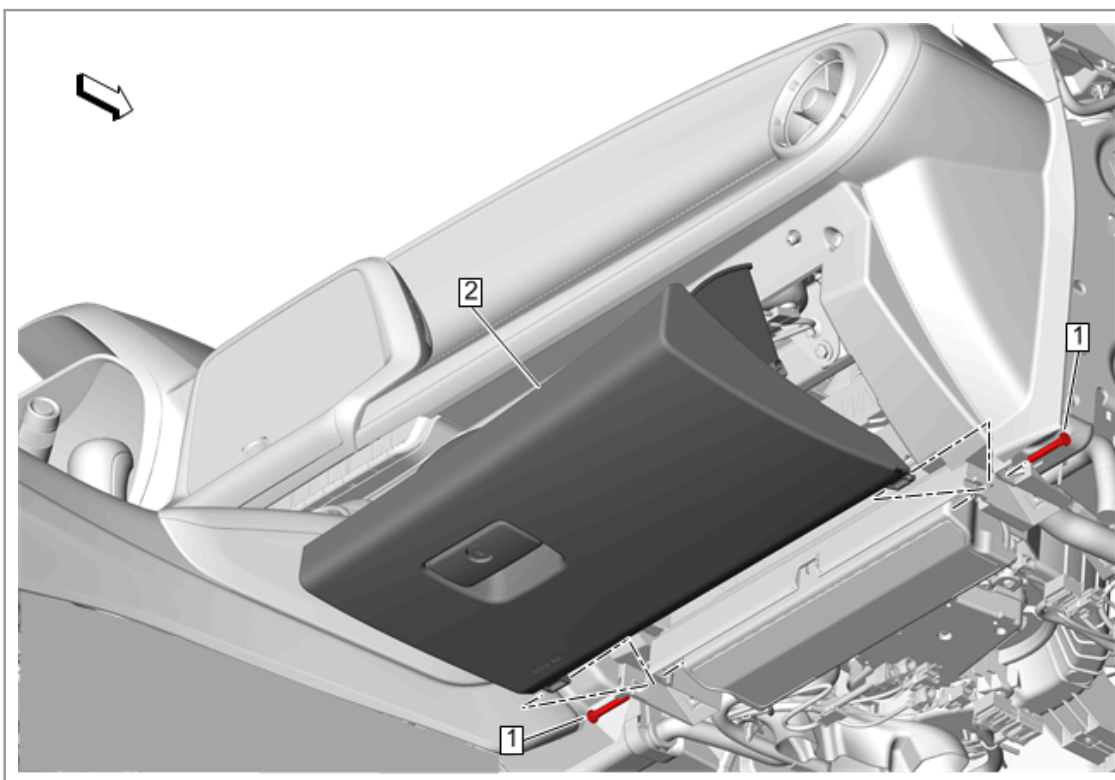
**5. Instrument Panel Compartment Replacement(2) >> Remove**

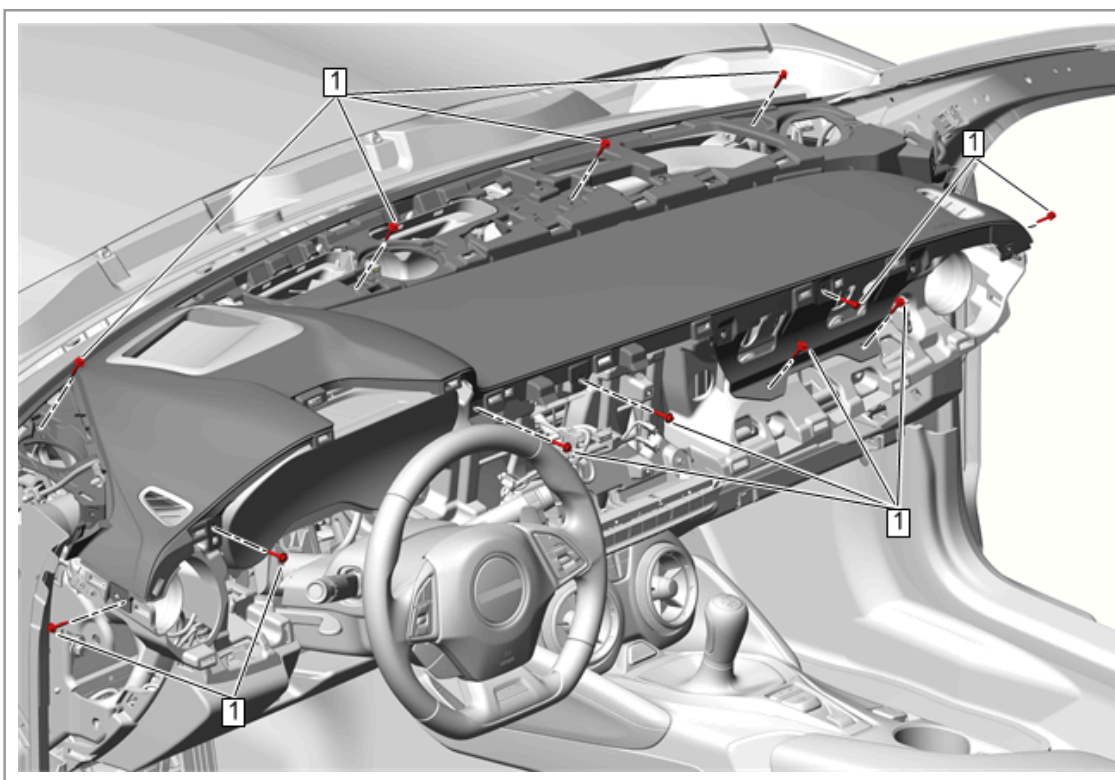
**6. Instrument Panel Bolt (1) >> Remove [12x]**

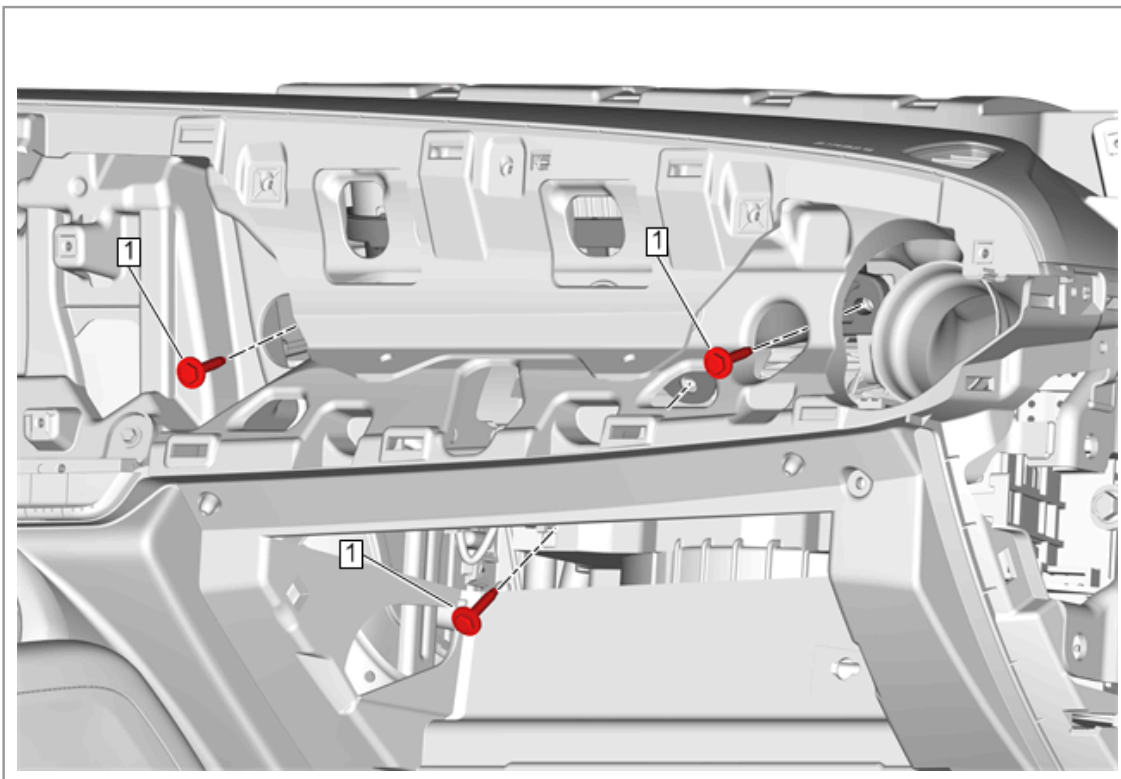
**7. Instrument Panel Airbag Bolt (1) >> Remove [3x]**

**8. Disconnect the electrical connector.**

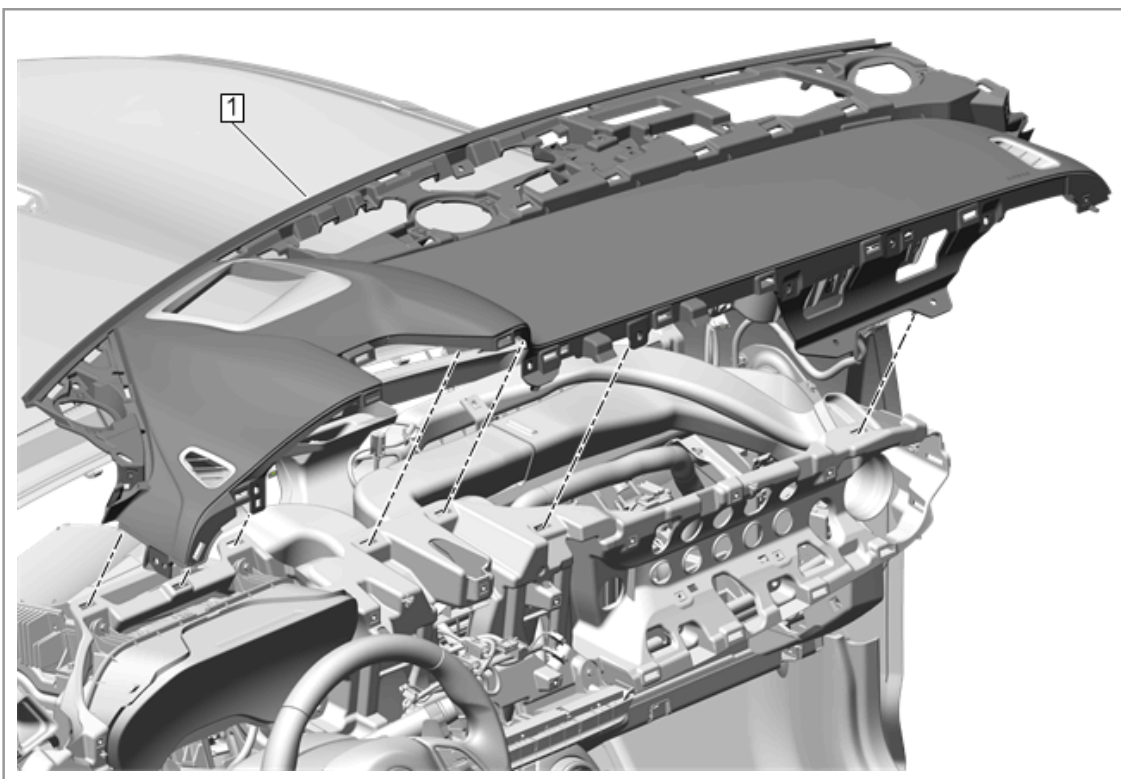
**9. Instrument Panel Upper Trim Panel Cover (1) >> Remove**

10. Disconnect and reposition harness as necessary.
11. With the aid of an assistant, remove the instrument panel upper trim panel cover from the vehicle.(1)
12. Transfer components as necessary.

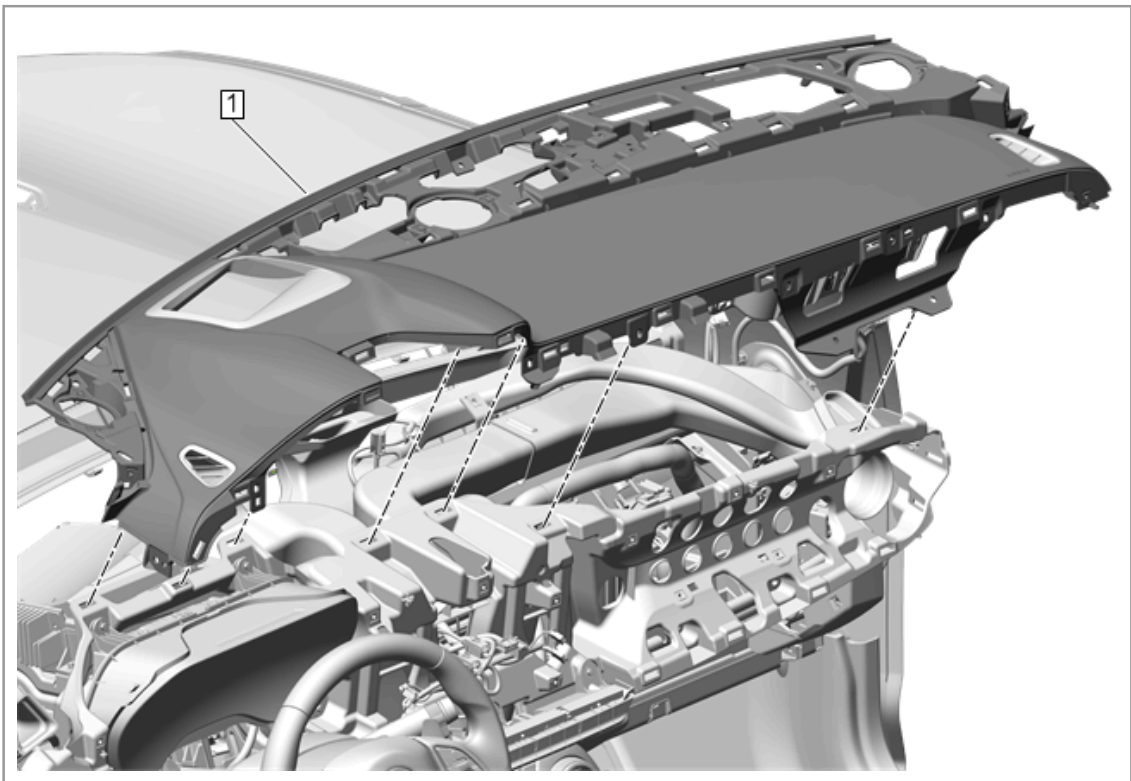
1. With the aid of an assistant, position the instrument panel upper trim panel cover into the vehicle. (1)

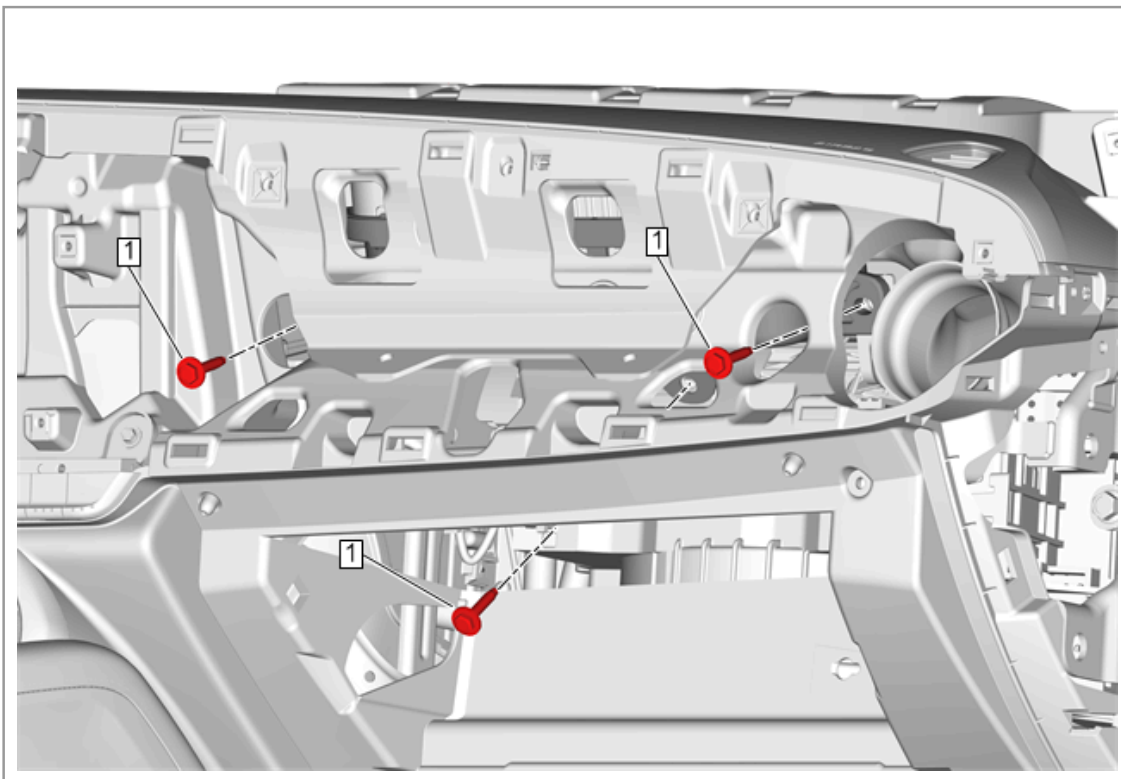
**Caution:** Refer to Fastener Caution.

2. Instrument Panel Airbag Bolt (1) >> Install and tighten [3x] 9 N-m (80 lb in)
3. Connect the electrical connector.

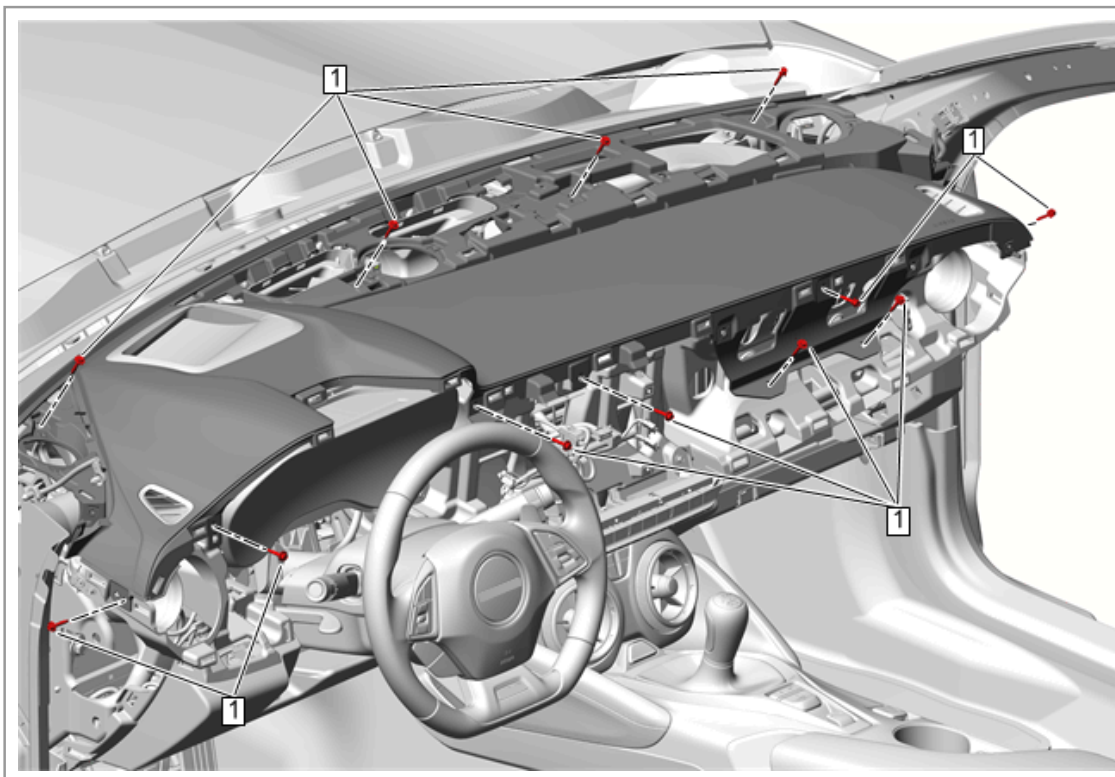
4. Instrument Panel Bolt (1) >> Install and tighten 2.5 N-m (22 lb in)

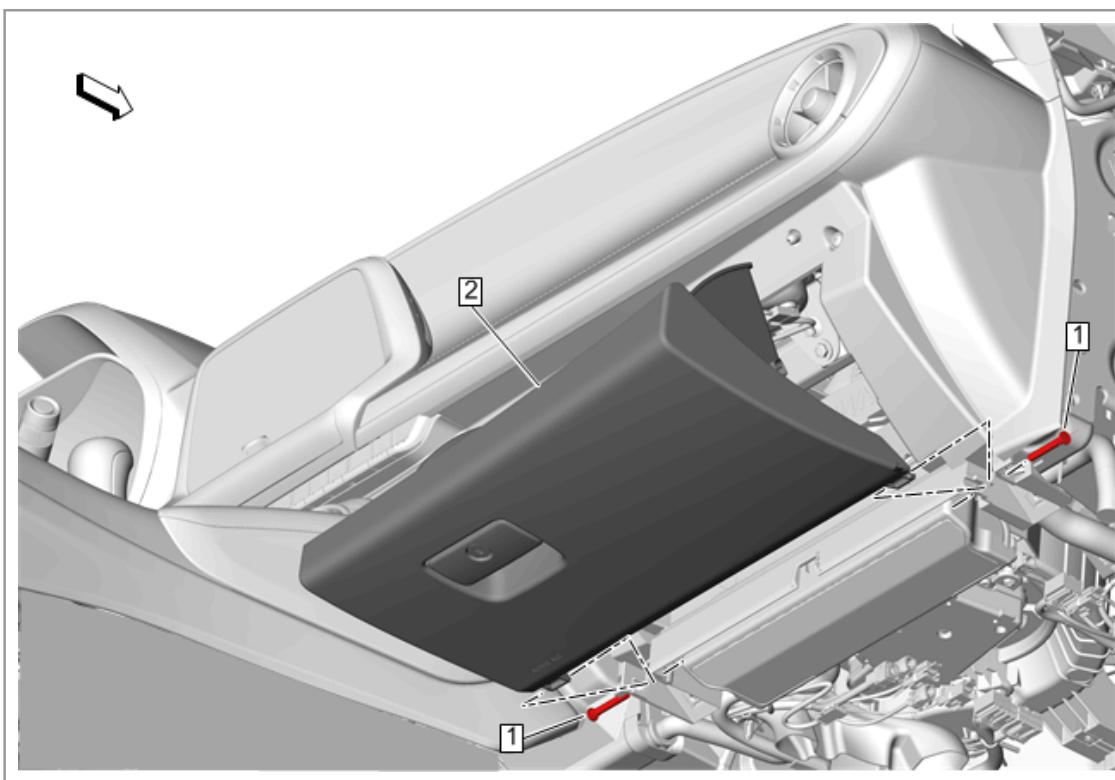
5. Instrument Panel Compartment Replacement(2) >> Install

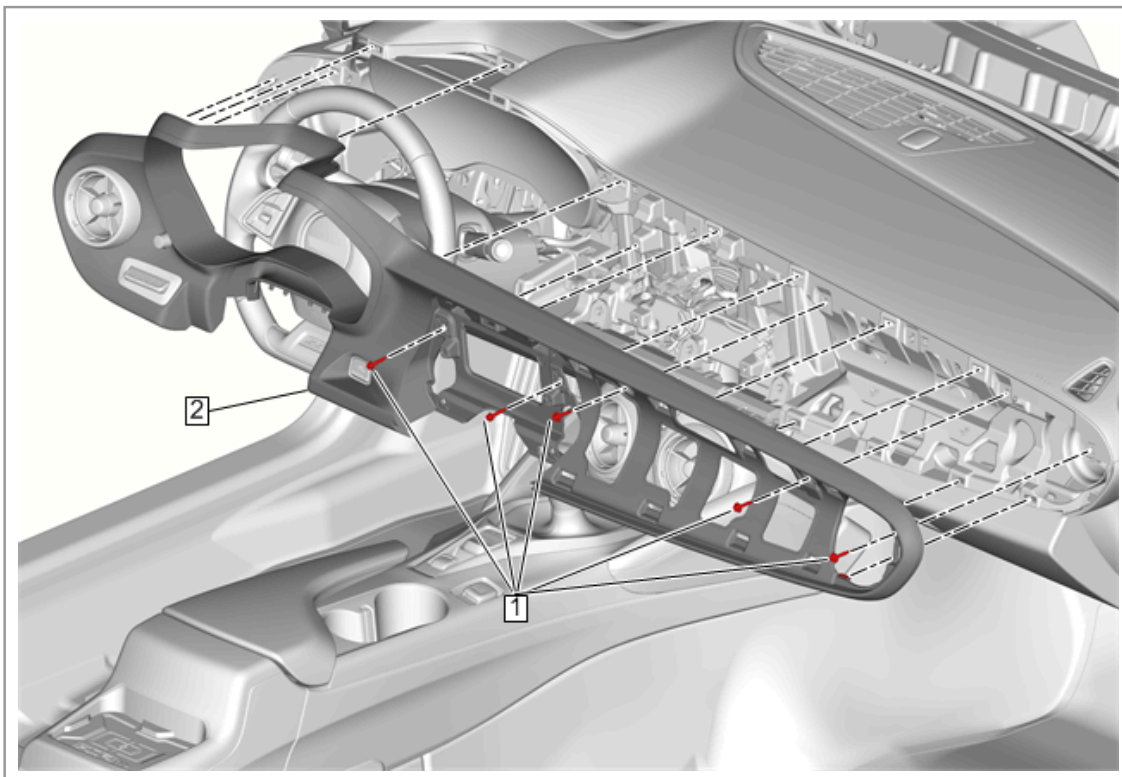
**6. Instrument Panel Cluster Trim Plate Replacement(2) >> Install**

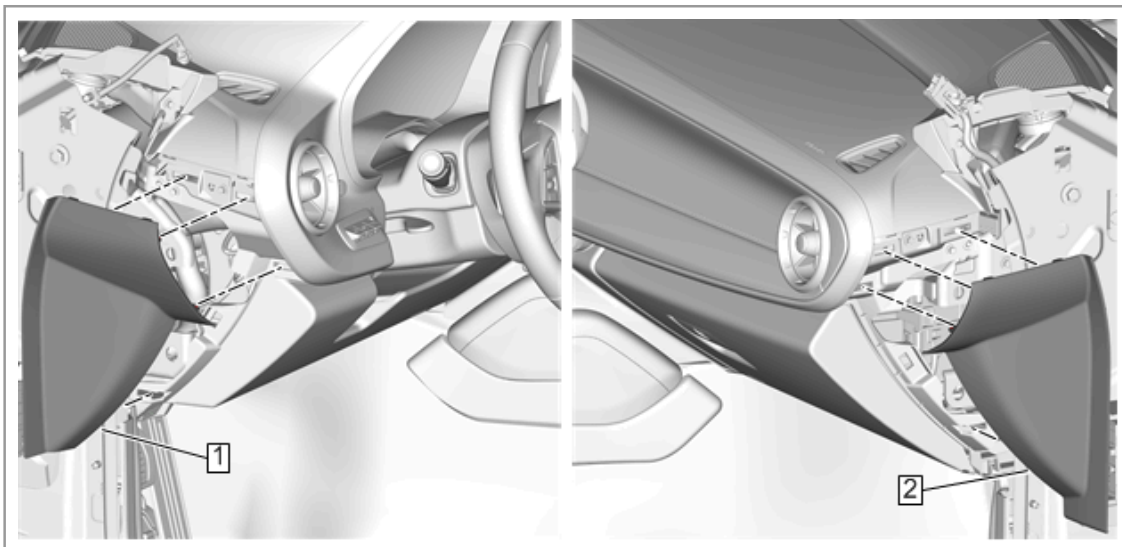
**7. Instrument Panel Outer Trim Cover Replacement(1) >> Install**

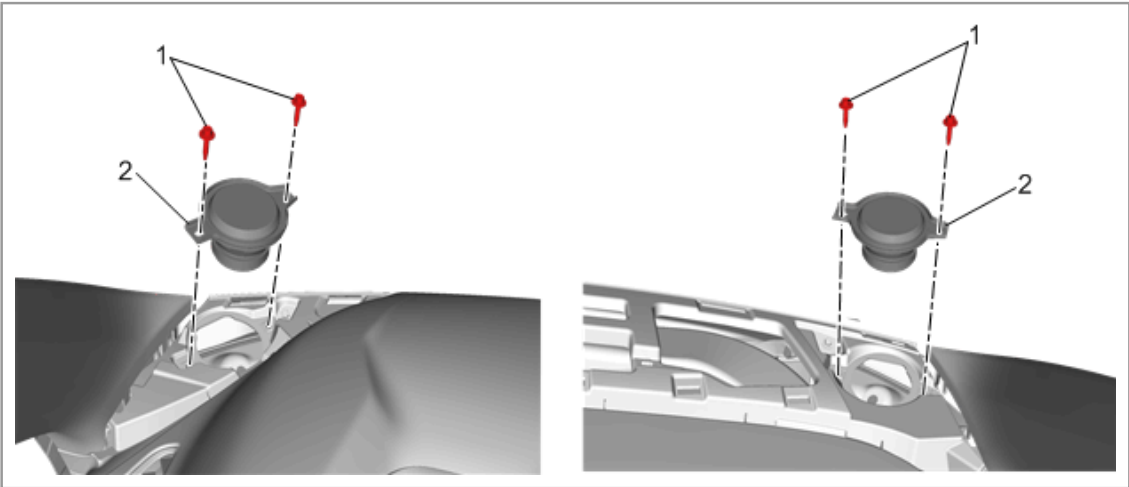
8. Radio Front Speaker Replacement(2) >> Install

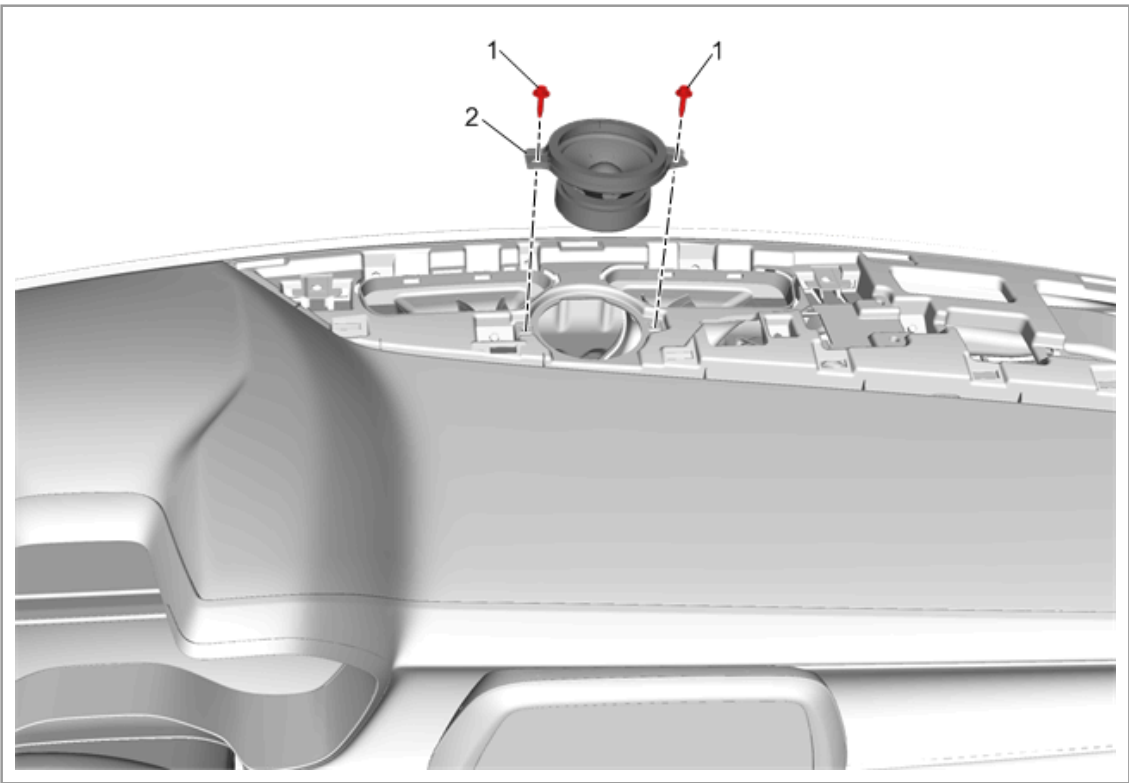
9. Radio Front Center Speaker Replacement(2) >> Install
