[2017 Chevrolet Camaro \[1G1FE1R75H0161496\]](#) | [Camaro Service Manual 10049487](#) | [Body Hardware and Trim](#) |  
[Instrument Panel and Console Trim](#) | [Repair Instructions](#) | Document ID: 4180641

## Multiuse Module Bracket Replacement - Instrument Panel

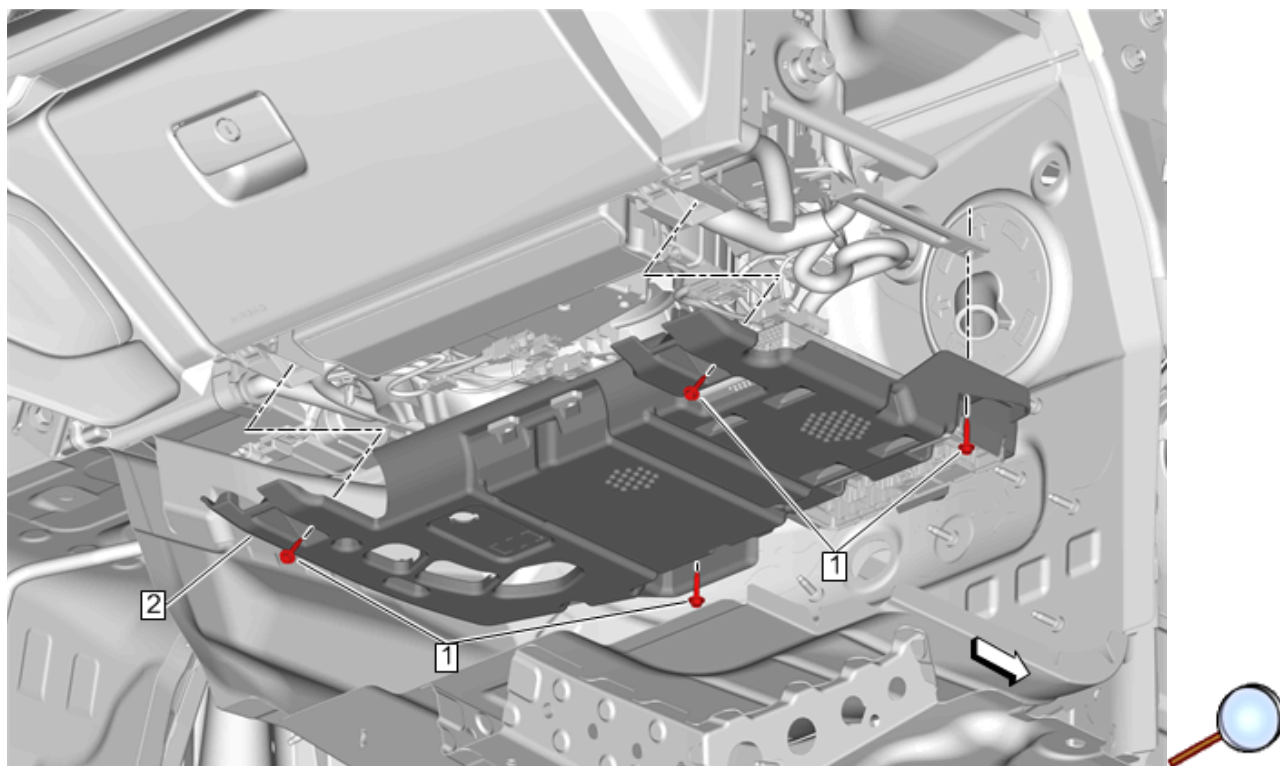
### Multiuse Module Bracket Replacement - Instrument Panel

| Callout | Component Name |
|---|---|
| 1 | Multiuse Module Upper Tray Bolt [4x]<br><b>Caution:</b> Refer to <a href="#">Fastener Caution</a> .<br><b>Tighten</b><br>2.5 N•m (22 lb in) |
| 2 | Multiuse Module Bracket<br><b>Procedure</b><br><ol style="list-style-type: none"><li>1. Disconnect the electrical connectors.</li><li>2. Transfer components as necessary.</li></ol> |
