2017 Chevrolet Camaro [1G1FE1R75H0161496] | Camaro Service Manual 10049487 | Body Hardware and Trim | Instrument Panel and Console Trim | Repair Instructions | Document ID: 4180815

Instrument Panel Compartment Replacement

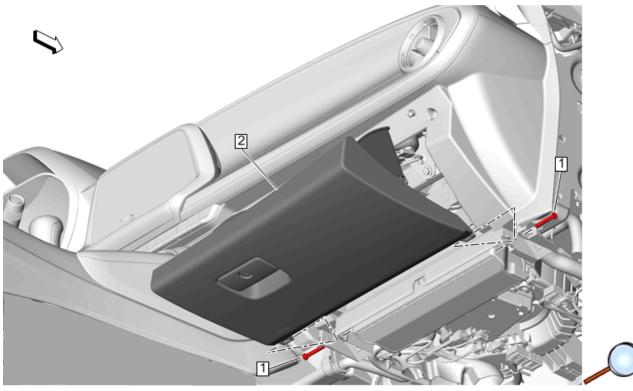
Instrument Panel Compartment Replacement

| Callout | Component Name |
|---|--|
| 1 | Instrument Panel Compartment Door Hinge [2x] Procedure 1. Use a suitable tool. 2. Release the retaining tabs. |
| 2 | Instrument Panel Compartment Procedure 1. Disconnect the instrument panel compartment door dampener from the instrument panel compartment door. 2. Squeeze the sides of the compartment and lower the compartment past the stops. |
